Safety Stand Down on Fall Protection

June 12, 2017

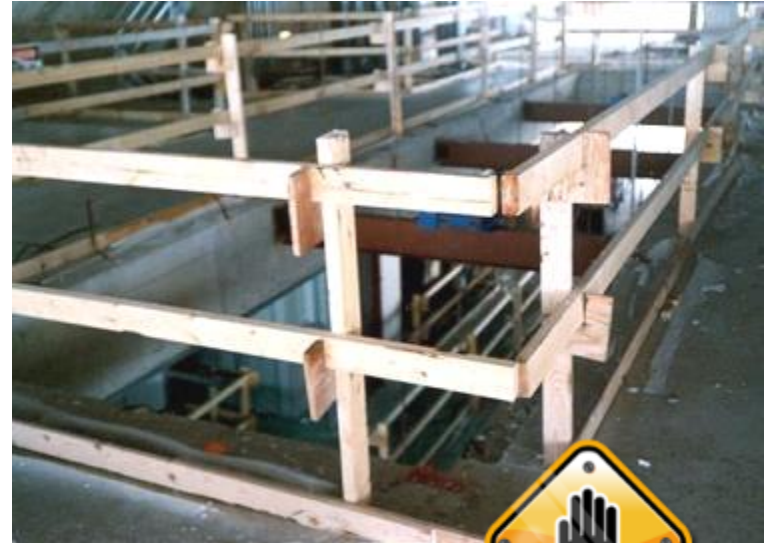
Guardrail Systems:

- Toprail 42 +/- 3 in.
- Midrail at 21 in.
- Toeboards
- Wire rope guardrails flagged every 6 ft.

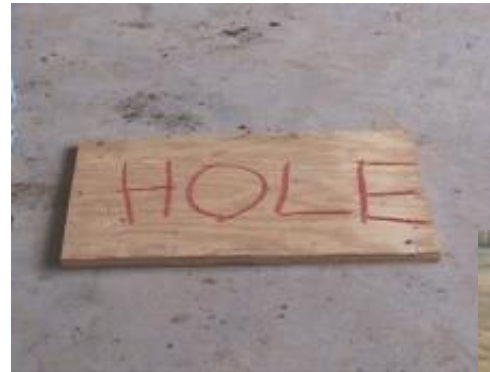
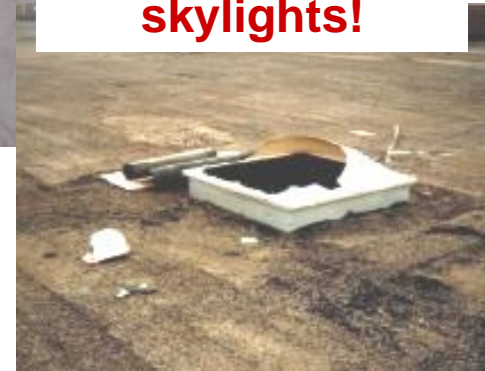
Holes (Anything over 2 inches):

- Secured
- Marked "Hole" or "Cover"
- Withstand 2X intended load

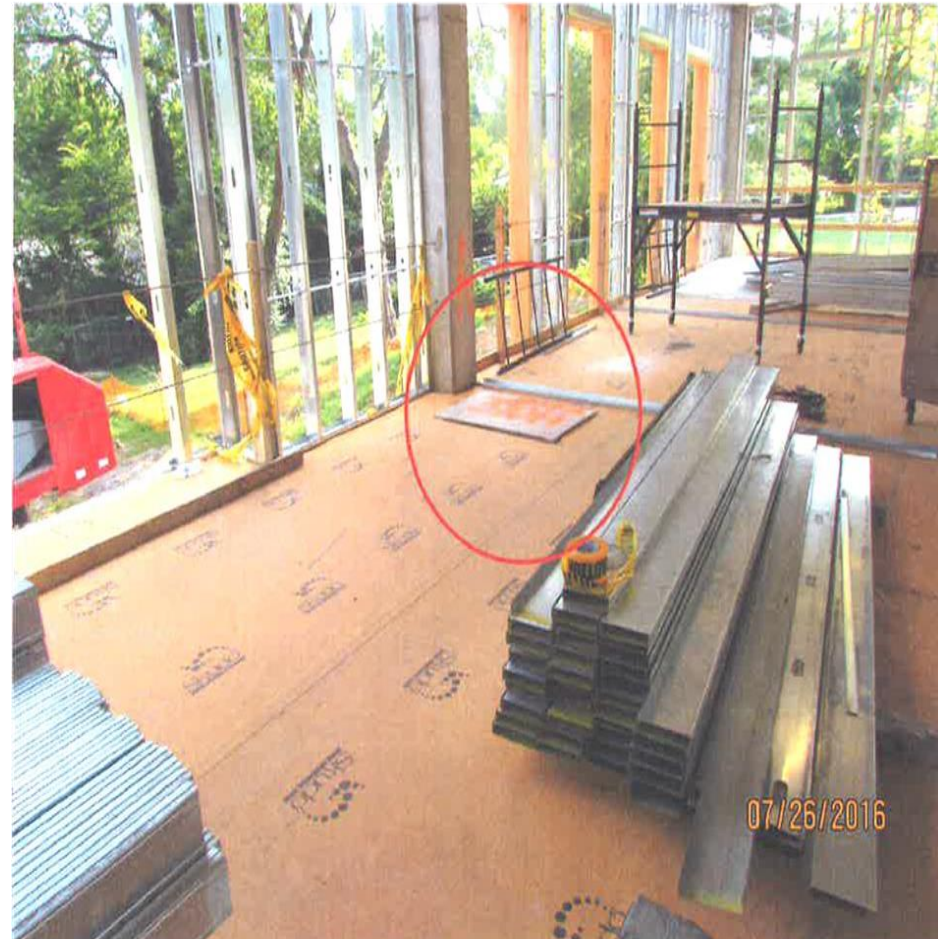
TOSHA Fatality Investigation – Fall through Floor Opening

A **59 year old male** employee was fatally injured when he stepped into a floor hole falling 15 feet 4 inches to the level below. On the day of the incident, the victim was working on the main floor of a newly constructed building framing windows. The victim moved some material to clear a space for a mobile scaffold, and in doing so he unknowingly lifted a piece of plywood that was covering a floor hole. The lead carpenter told the victim to put the board down, but the victim stepped forward falling into the 16 inch wide by 39 inch long floor hole striking his head on the concrete floor below. During the investigation it was determined that the cover was not marked, “HOLE” or “COVER”, to warn employees that a floor hole was underneath, and the cover was not anchored down to the floor. .

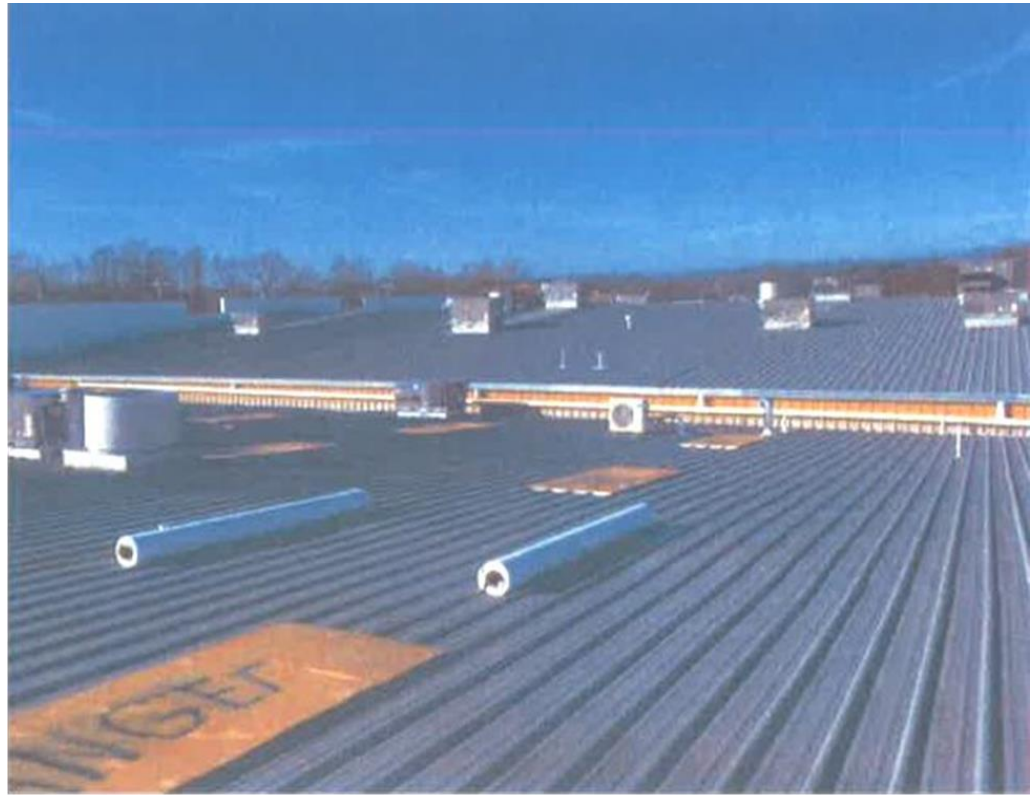
TOSHA Fatality Investigation – Fall through Skylight

- A **34 year old male** employee was fatally injured when he fell 30 feet to the concrete ground below. On the day of the incident, the victim, a roofer, was installing a waterproof membrane over an existing 30,000 square foot metal roof. The metal roof was equipped with 3x10 foot skylights that were flush with the surface of the roof and positioned throughout the working space. Due to the low slope of the roof, fall harnesses were not provided, and a warning line system was used to protect employees from fall hazards. Employees were instructed to watch out for the unprotected skylights. While the victim was moving material around the rubber membrane covering a skylight, he unknowingly stepped onto the unprotected skylight causing it to break, falling 30 feet to the concrete ground below.

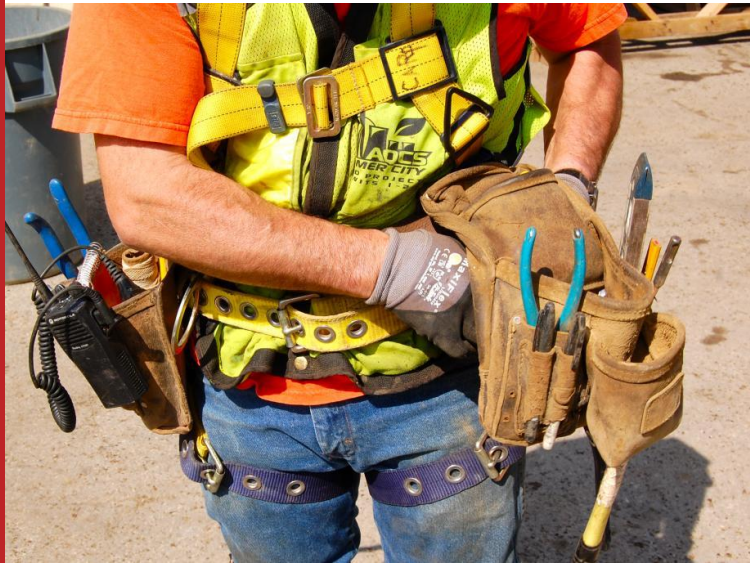
Personal Fall Arrest System Requirements

- Always inspect prior to use
- Anchor overhead whenever possible
- Wear the harness properly
 - **D-ring between shoulder blades**
 - **Harness should be snug**
 - **Should fit properly**

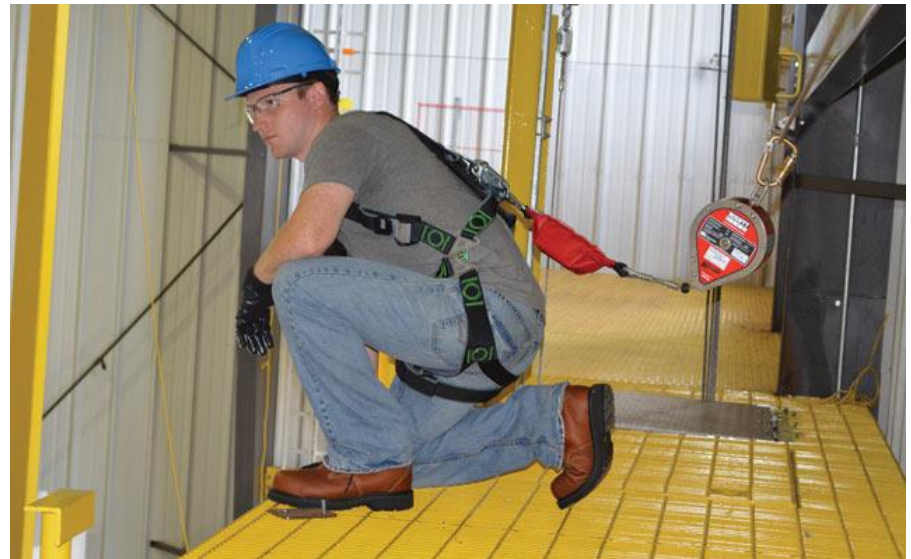
All Self Retracting Lifelines (SRLs) are not created equally!

Fall protection when working on a site that involves open edges and roofs is extremely important, and it requires a different type of SRL. The retract needs to be designed to minimize the impact on itself when a fall occurs going over a ledge, and it needs to be able to be easily positioned either overhead, at foot level, or at the level of the leading edge. Among the many features of a leading edge SRL is their integrated shock-absorbing pack that helps limit the impact of a fall's force on the cabling that is in contact with the ledge itself. This design allows overhead, foot level, or leading edge placement.

**See
manufacturer's
information for
clearances!**

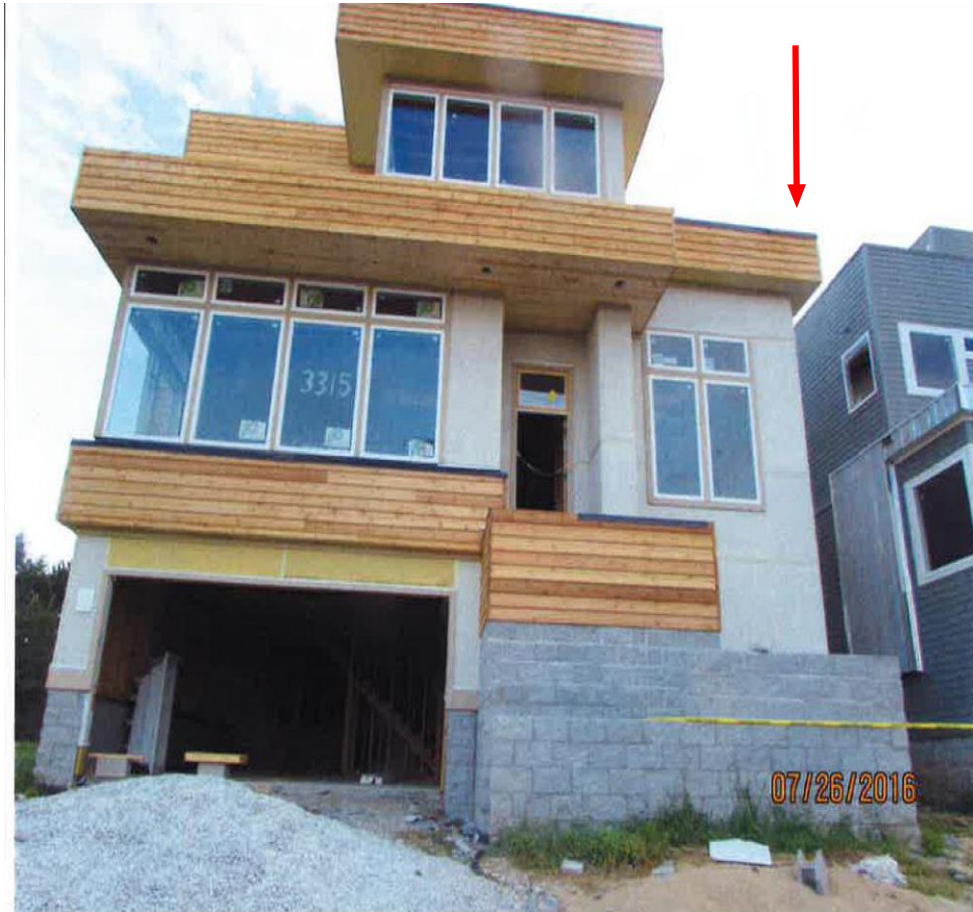
TOSHA Fatality Investigation – Fall from Roof

- A **30 year old male** employee was fatally injured when he fell approximately 30 feet from the roof of a residential house. On the day of the accident, the victim was installing coping, a custom aluminum cap, along a 6 inch tall parapet wall surrounding a flat roof. The victim and co-worker had been working on the roof 4 to 5 hours before lunch. Shortly after returning to work from lunch, the co-worker heard the victim yell and when he turned around the victim was gone. During the investigation it was determined that fall protection, harnesses and lanyards, were available onsite, but the employer did not see a hazard since they were working on a flat roof and did not require their use. The employer did not provide another form of fall prevention such as a guardrail system or safety net system to keep the employees from falling from the leading edge of the roof.

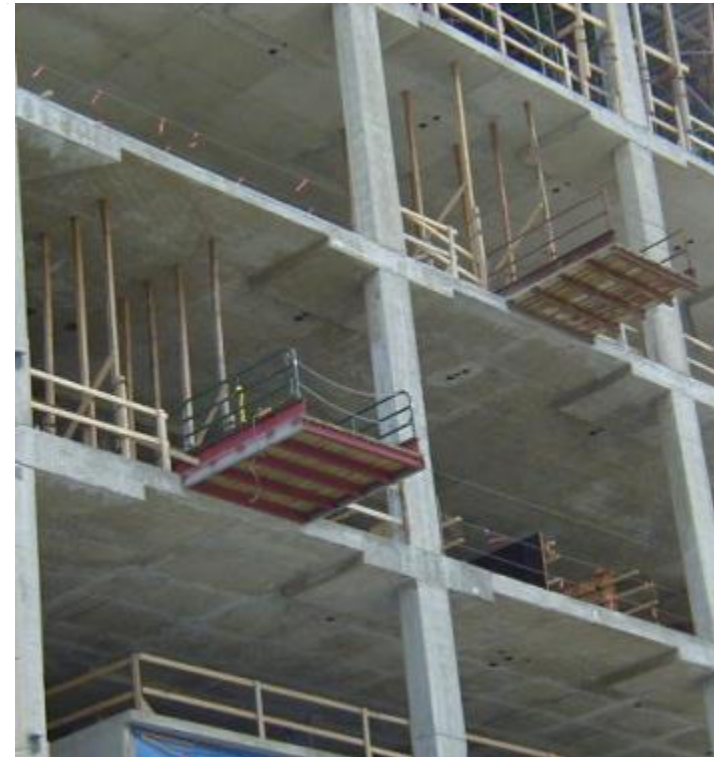
Hoist Areas

- Material handling platforms must have guardrails.
- BEFORE guardrails are opened to receive material, workers must be tied off.
- The area should be enclosed so others aren't exposed.

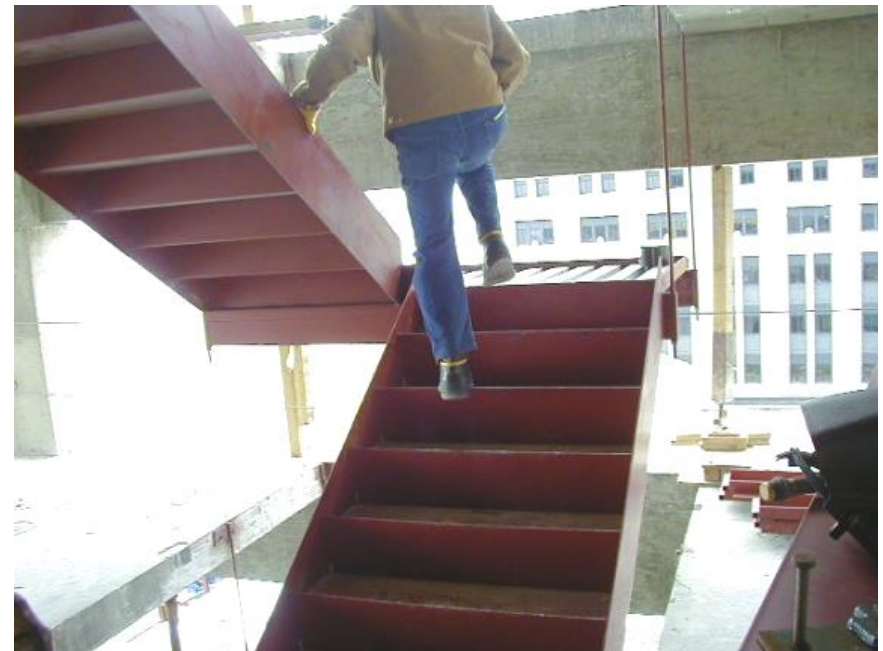
Stairways

- Stair pans should not be used for access until poured or filled, and stair rails have been installed.
- Be sure all debris is removed immediately.
- Keep cords off of stairway treads.

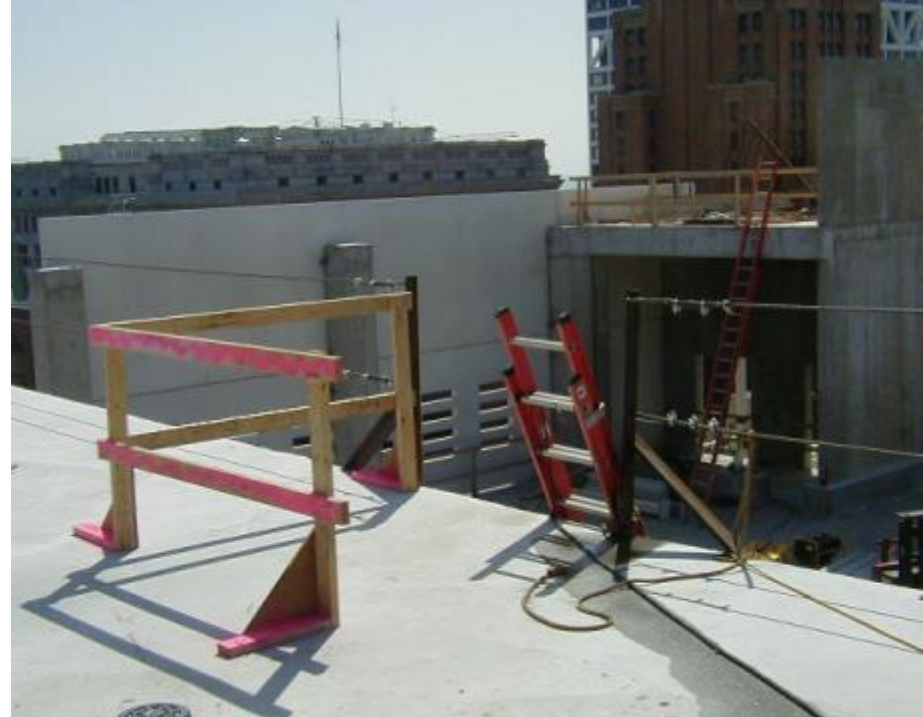
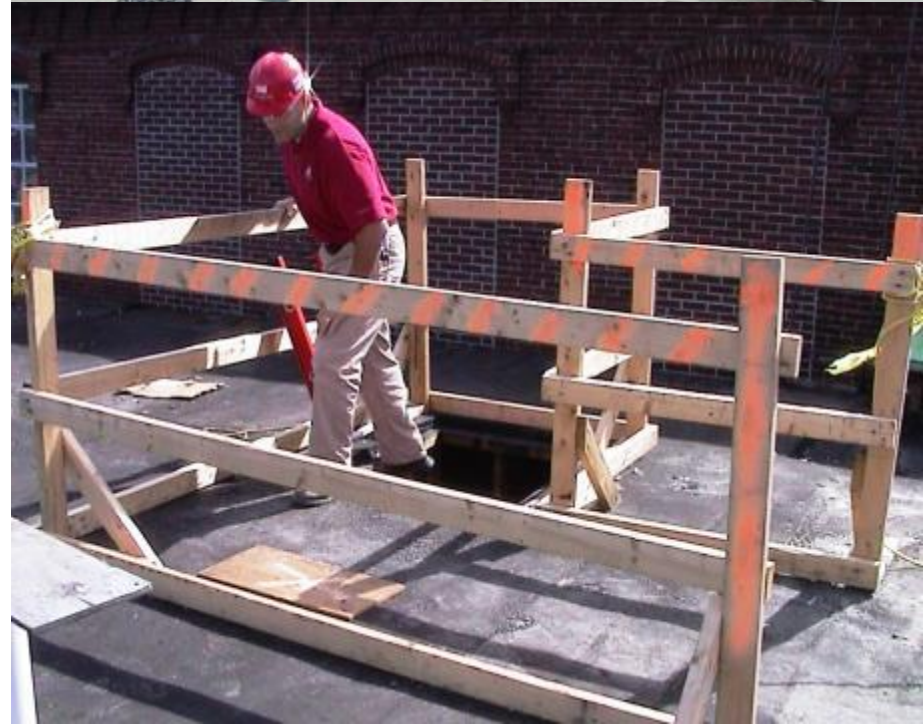
Access Ways

- Offset guardrails are recommended.
- Watch for tripping hazards at tops of ladders and stairs.
- Avoid configuring ladders so that people have to climb through guardrails to egress.

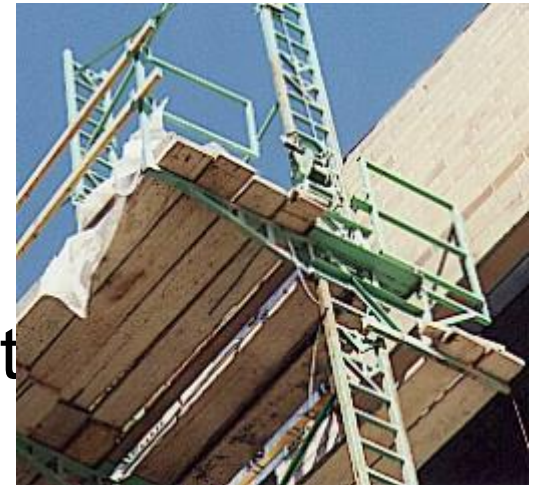
Scaffold Requirements

- Firm foundation with base plates
- Plumb, square and adequately braced
- Have a fully planked work deck
- Have guardrails over 10 feet (Best management practice – install guardrails at all heights.
- Tie scaffold into structure as per manufacturers requirements.
- 6” overhang on planks; 12” overlap over supports.
- Have a safe means of access.

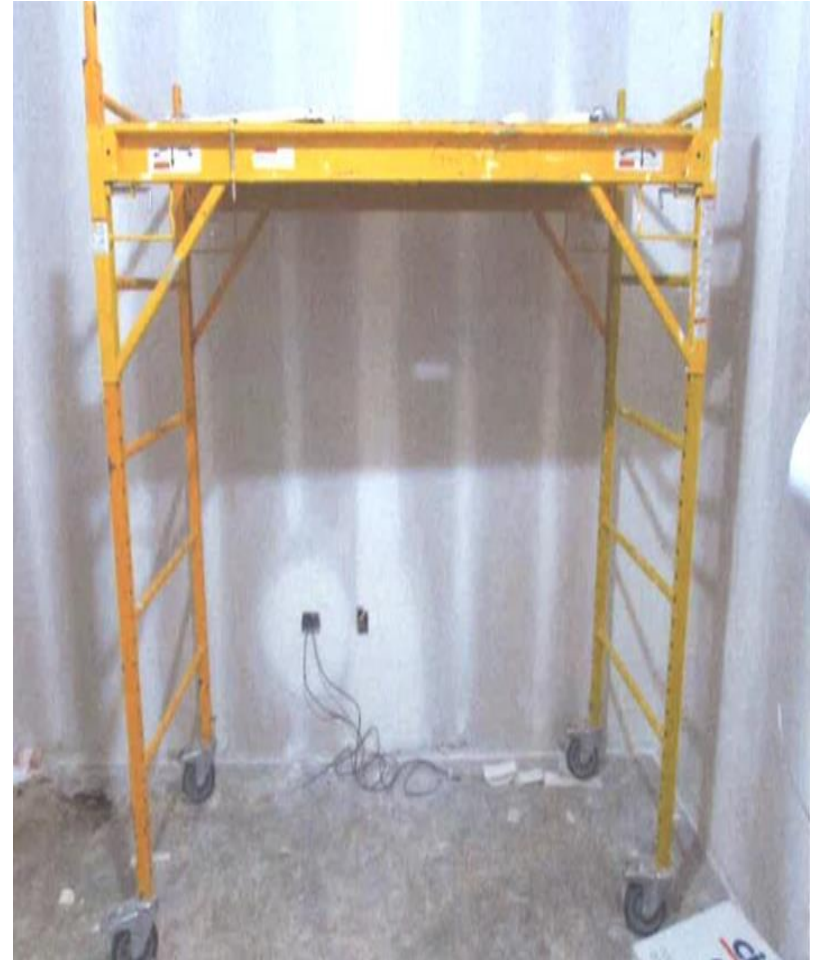
TOSHA Fatality Investigation – Fall from Baker Scaffold

- A **29 year old male** employee was fatally injured when he fell **5' feet 5" inches** from a baker scaffold striking his head on the concrete floor. On the day of the accident, the victim was working alone, finishing drywall from a baker scaffold, when fellow workers heard a noise. They found the victim unresponsive and bleeding next to the scaffold. There were no witnesses to the accident. During the investigation and interviews, it was determined the caster/wheel locks on the baker-style scaffold were not engaged which could have allowed movement of the scaffold causing the employee to lose his balance and fall. The employer had not provided scaffold training by a qualified person, and did not have a competent person to inspect the scaffolds.

- The two scaffold fatalities described occurred at heights of 5.5 ft. and 6 ft., respectively.
- OSHA requires fall protection on scaffolds at a height of 10 ft., which would not have prevented these accidents.
- OSHA regulations are minimum requirements. To prevent injuries we need to go above and beyond!

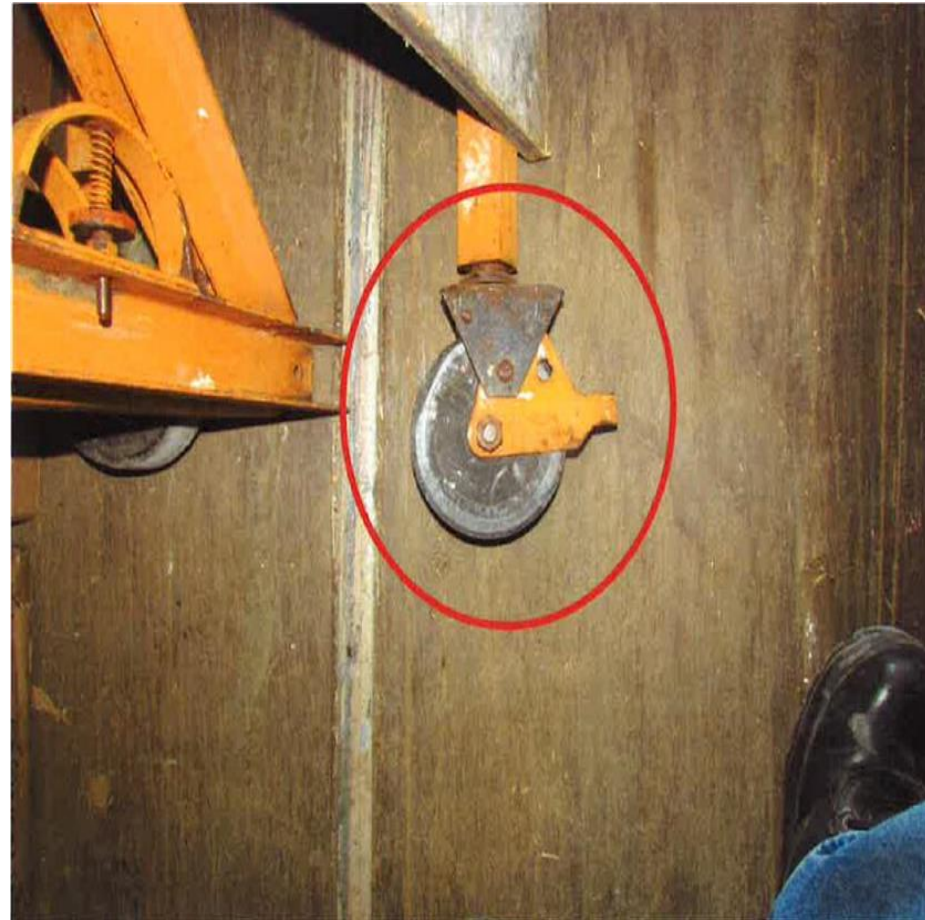
Another Fall from Baker Scaffold

- **47 year old male** employee was fatally injured when he fell and struck his head on a concrete pad. On the day of the incident the victim, a framer, was installing Tyvek waterproofing material on a wall at a newly constructed commercial building. He was working from a baker-style scaffold at a height of approximately **6 feet** from the concrete pad. Several employees working in the area heard a loud noise and ran to investigate. They found the victim lying on the ground unresponsive with an apparent head injury. There were no witnesses to the incident. During the investigation it was determined that the wheel locks on the baker-style scaffold, when engaged, did not prevent movement of the scaffold. The scaffold was not inspected by a designated competent person before each work shift for deficiencies.

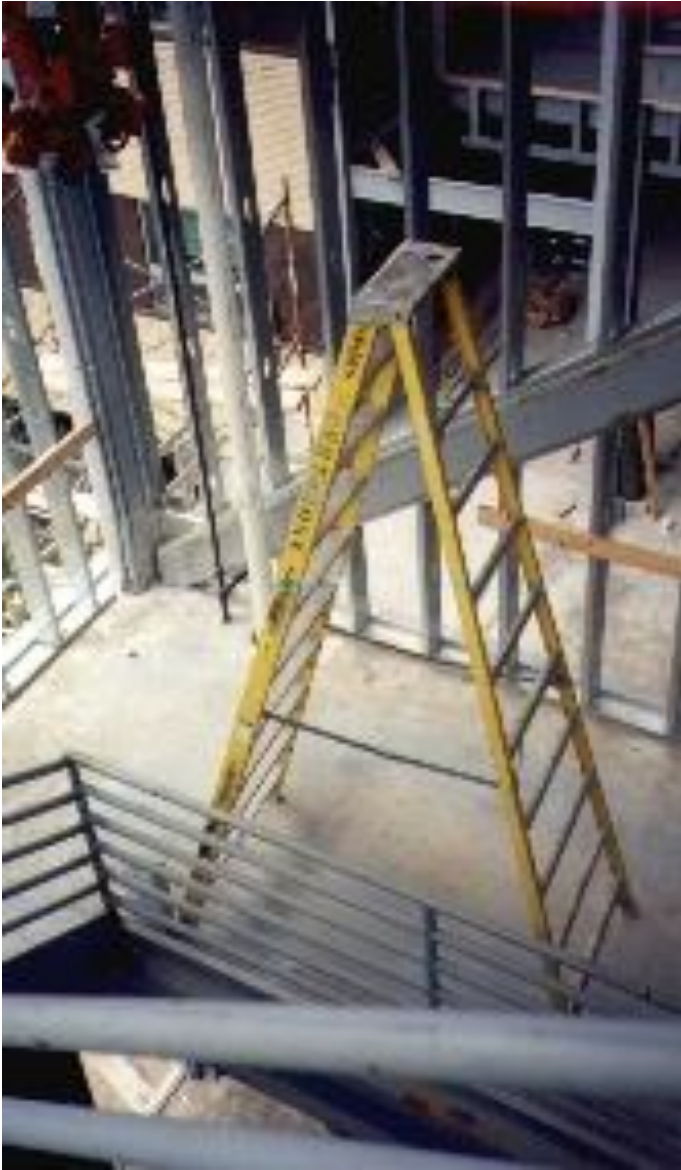
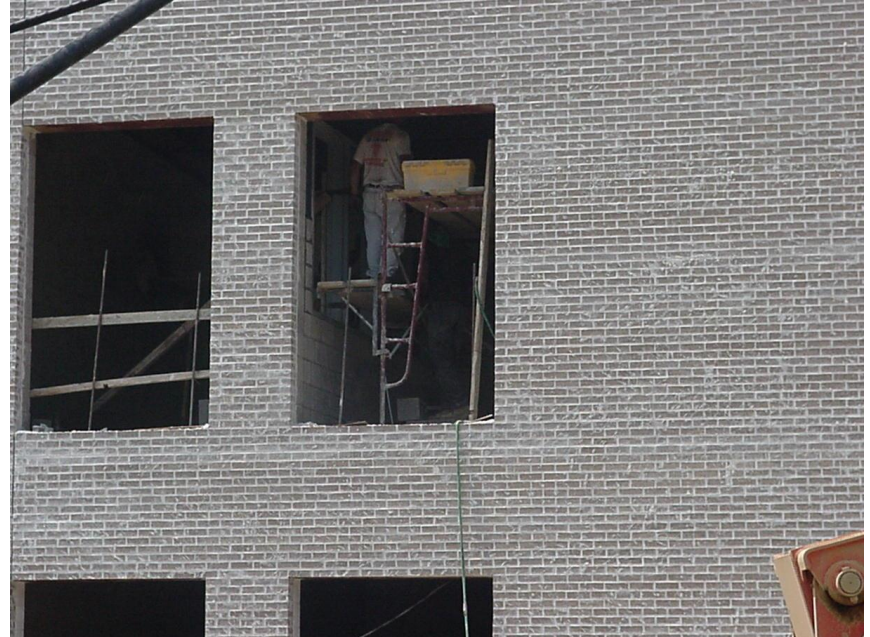
Working Above Protective Systems

When employees work above railings, they must be protected from falling over the railings.

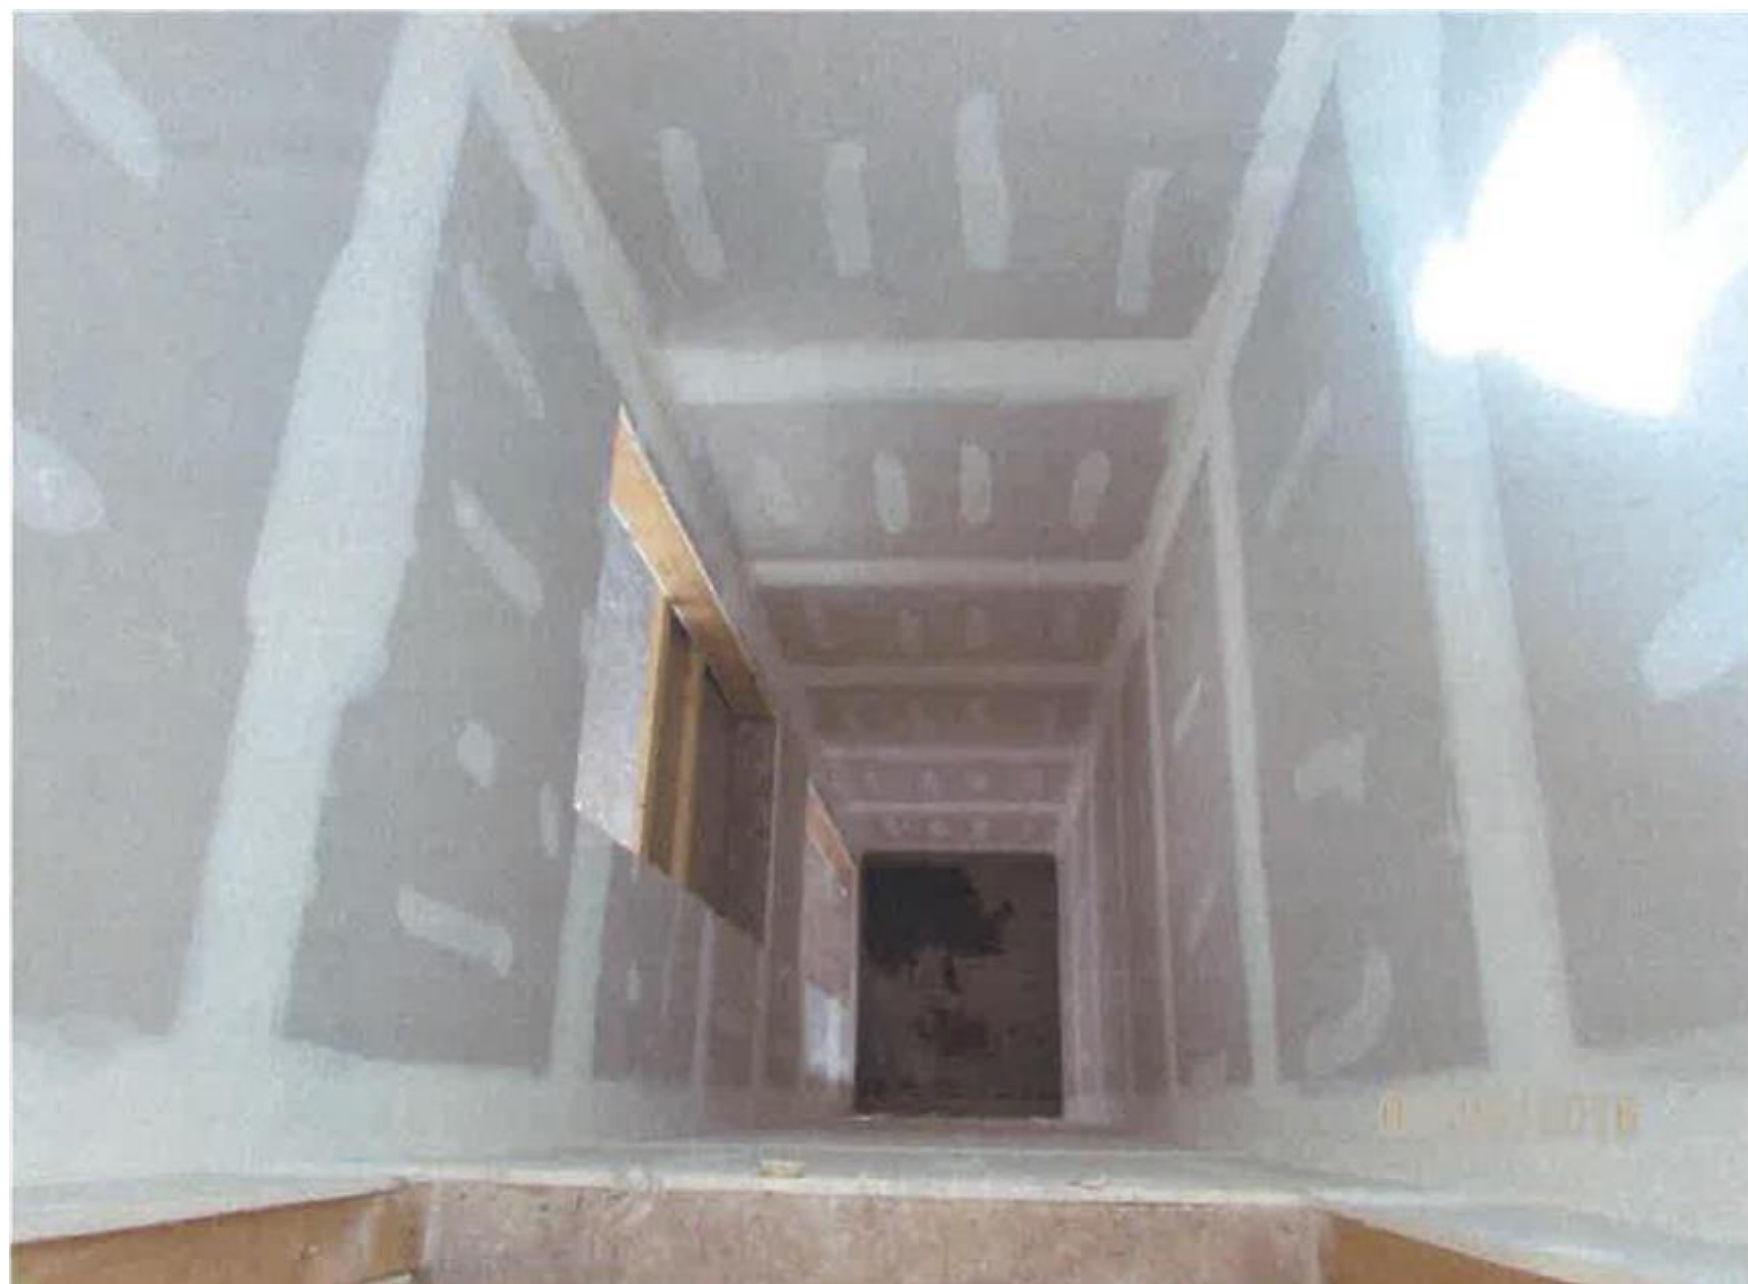
TOSHA Fatality Investigation – Fall from Work Platform

A **38 year old male** employee was fatally injured when he fell 27 feet down an elevator shaft to the concrete floor below. On the morning of the incident, the owner/victim, and his employee began drywall finish work at the third level of the elevator shaft. The employee and victim used a metal plank work platform (8 to 10 inches wide) to extend into the shaft approximately 8 feet, with multiple packages of roofing shingles, stacked as a counterweight, on the portion of the plank that did not extend into the shaft. While the employee was working on the plank finishing the drywall inside the elevator shaft, the victim stood on the packages of roofing shingles to add to the counterweight. At a point during the day, the employee came off the plank, and sat down to remove his stilts. In mid-conversation, the employee noticed that the victim was no longer talking. The employee went to check on the victim, and found him at the bottom of the elevator shaft. During the investigation it was determined, that the victim assumed the packages of shingles could support his weight, and he stepped out onto the metal plank suspended over the elevator shaft. The victim and his employee were not wearing fall protection. The victim was the sole owner therefore citations were not issued since the company no longer exists. However, the general contractor was cited since they were the controlling contractor, and allowed others on-site to be exposed to a fall hazard without protection.

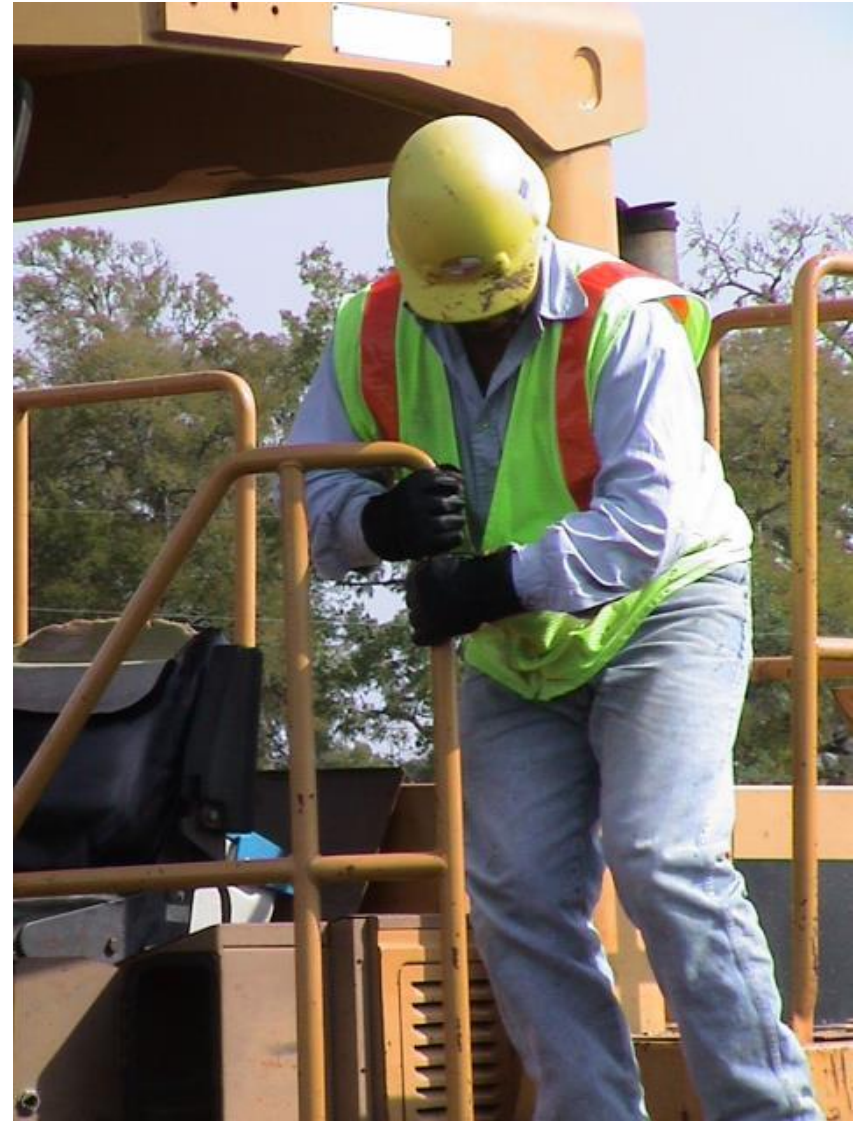
Prevent Falls from Mobile Equipment

- Do not jump from equipment.
- Use three points of contact at all times.
- Be sure of your footing.
- Be sure steps are clear of mud and ice.
- Repair/ replace damaged steps immediately.

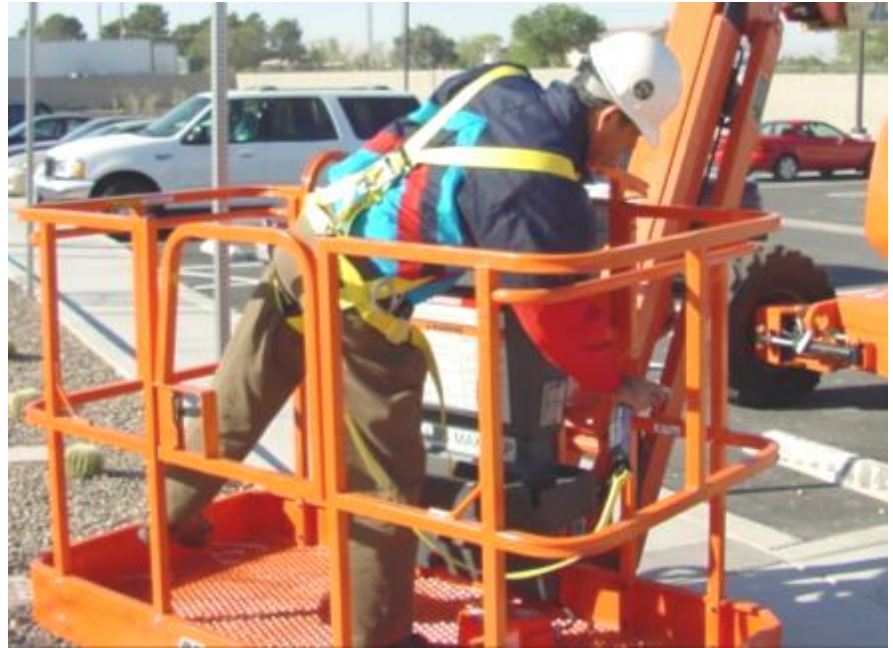
Articulating boom lifts

- Fall protection is required.
- Employees should be trained.
- Inspect area for holes or drop offs.
- Tie off to designated anchorage point and always the lowest anchorage point possible.
- Do not anchor to anything outside the lift.
- Remember to complete the guardrail by closing the gate.

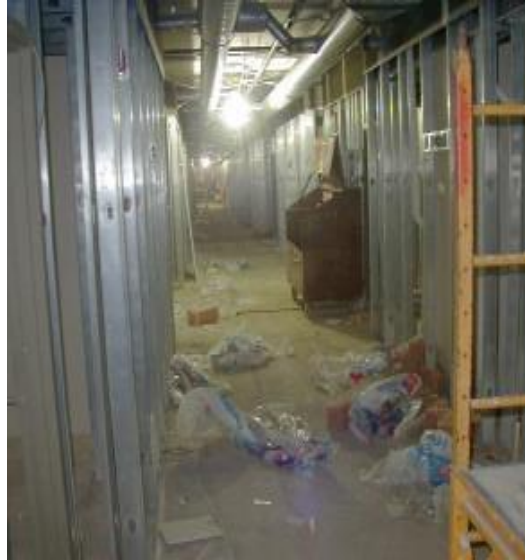
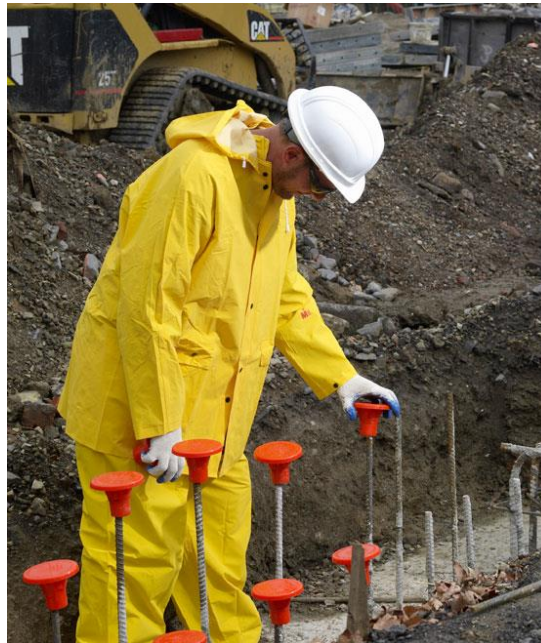
Same Level Falls

- Watch out for trip hazards
- Trash and debris, esp. items like conduit or pieces of hanger rod create hazards for everyone in the building

- Watch for slick surfaces
- Make sure lighting is adequate
- Watch for items like rebar that someone could fall onto and be injured if not capped properly
